REMOTE SENSING PILOT PROJECT: EVALUATING THE EFFECTIVENESS OF LARGE FLOODPLAIN AND RIPARIAN RESTORATION PROJECTS USING REMOTE SENSING

Phil Roni, Jake Kvistad, Shelby Burgess, and Kai Ross
Cramer Fish Sciences
Watershed Sciences Lab
1125 12th Avenue NW, Suite B-1
Issaquah, WA 98027

RCO Project 21-1328

March 31, 2023

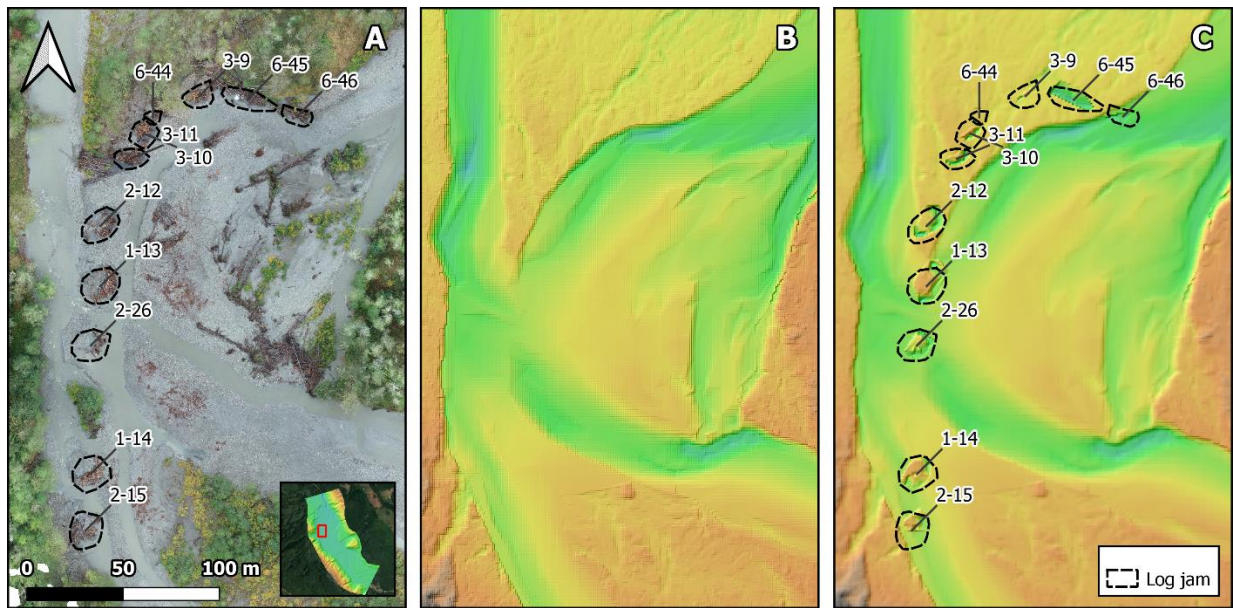
Figure 6. Example displaying how constructed log jams (A) were mosaicked with the pre-project LiDAR surface (B) to create an as-built DEM with project design elements included (C).

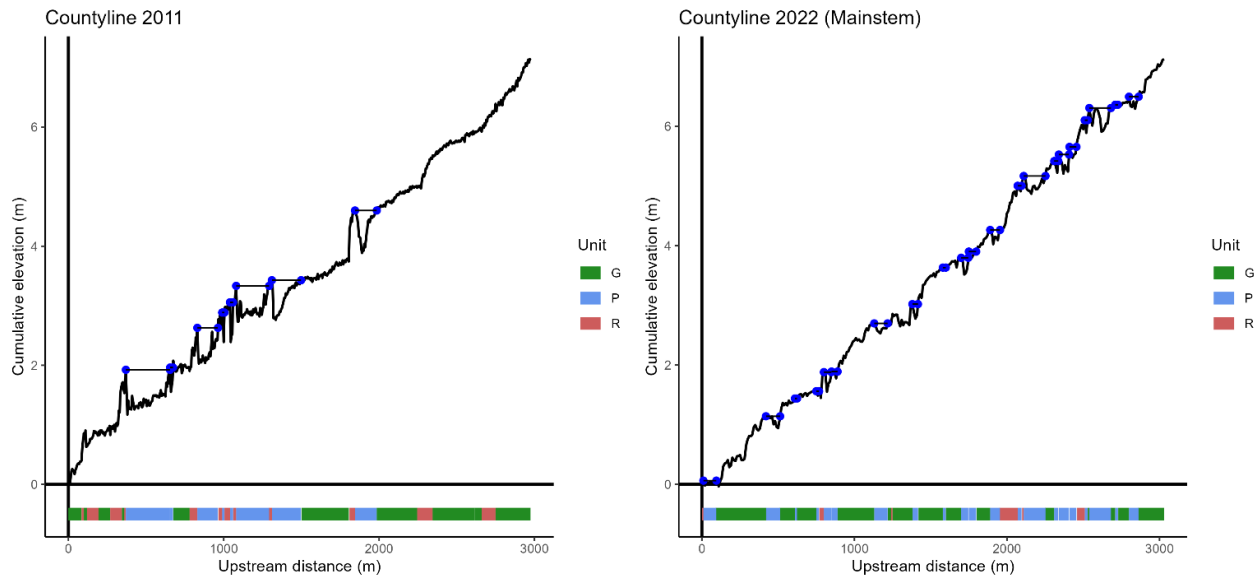
Figure 11. Thalweg long profile and results from habitat classification for Countyline (mainstem only). Habitat unit type definitions are as follows: G = Glide, P = Pool, R = Riffle.

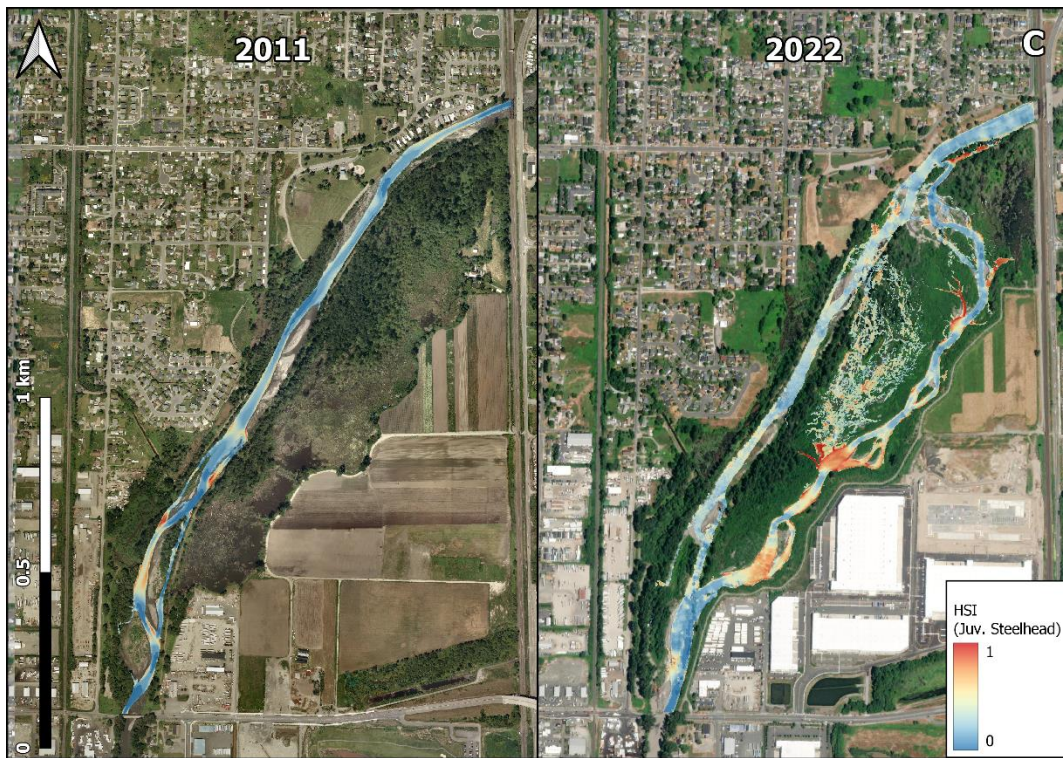
Figure 15. Habitat suitability index results for Countyline at low flow (500 cfs) for juvenile steelhead. Base maps are 2011 (pre-project) and 2021 (post-project) NAIP imagery.

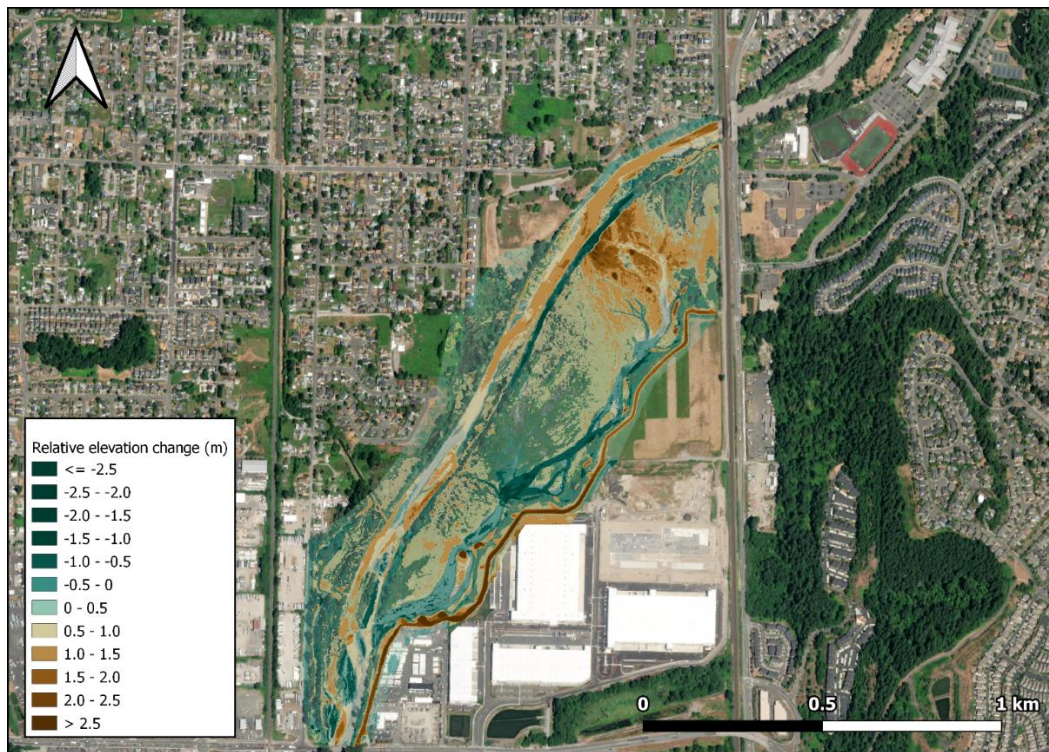
Figure 16. Relative elevation change at Countyline from 2011 to 2022 based on topo-bathymetric LiDAR.

The DEM of difference (2011 – 2022) at Countyline indicated that 81% of the project area (68.48 ha) has aggraded, for an estimated total sediment volume of 462,993 m³ (Figure 16). Concurrently, 16% of the project area (13.86 ha) has degraded, or 55,830 m³ of sediment. Thus, total aggradation at the site was 407,163 m³ of sediment. However, poor LiDAR penetration in 2022 may have resulted in biased estimates of aggradation and degradation in deepest areas of the channel.
